**HARVARD FAS  
EPS MUSEUM RENOVATION  
GOLD (PENDING)**

**LEED-CI V2.0**

**EPS Museum  
Harvard Department of Earth  
and Planetary Sciences  
2009 Renovation**

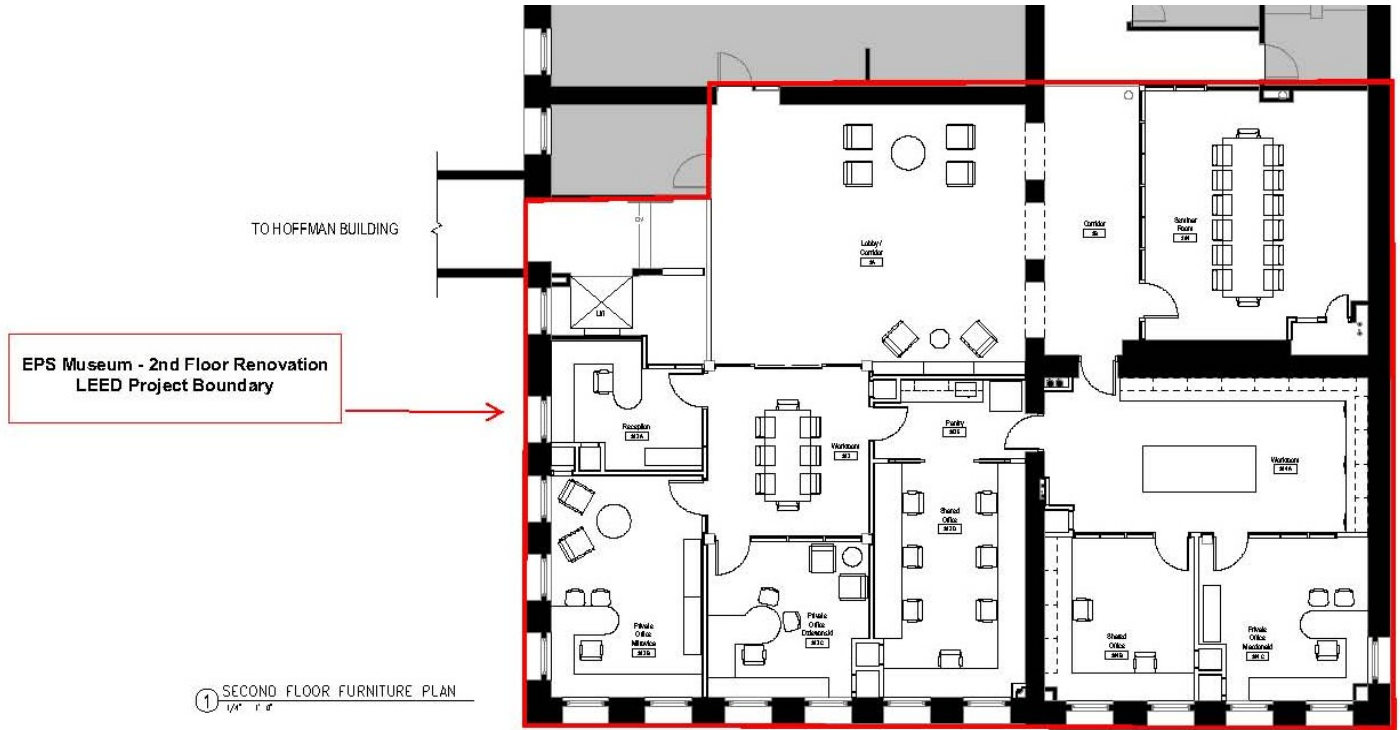
### EPS MUSEUM RENOVATION FLOOR PLAN & LEED BOUNDARY

This project is a renovation of approximately 3,500 square feet on the second floor of the Geology Museum to create faculty offices and support space for three professors with the Department of Earth and Planetary Sciences (EPS). In addition to the three private offices, the renovation will include offices for Post Docs, Graduate Students and a receptionist, workrooms, a seminar room, and a kitchenette. The Geology Museum is located within the 175,710 square foot Harvard University Museum at 24 Oxford Street in Cambridge, Massachusetts. The renovation occurred between September 2009 through December 2009.

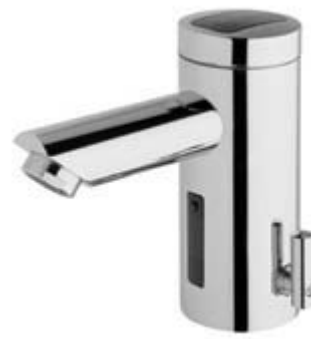
**SLOAN SOLIS®**  
Solar Powered, Electronic  
Hand Washing Faucet

Per LEED requirements, if a project boundary does not include bathrooms, calculations must be for the fixtures in the closest bathroom. The closest bathrooms to the EPS Museum Renovation have water efficient fixtures, which **reduce domestic water consumption by 34% over standard EPA 1992 fixtures**. This is the equivalent of saving over 8,561 gallons per year.

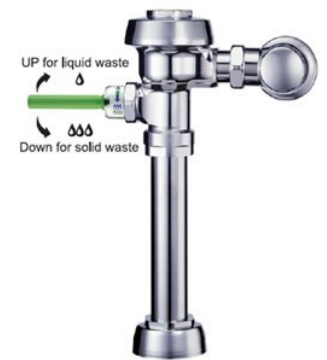
**SLOAN UPPERCUT®**  
Dual-Flush Flushometer  
(Up 1.1 gpf and Down 1.6 gpf)

Differences in the Flush & Flow Rates for EPA 1992 Standard Fixtures and the fixtures utilized by the EPS Museum Occupants		
Fixture Type	EPS Museum Flush & Flow Rates	EPA 1992 Standard Flush & Flow Rates
Water Closet [GPF]	1.1 or 1.6 Dual Flush	1.6
Urinal [GPF]	0.125	1.0
Bathroom Sink [GPM]	0.5	2.5
Shower [GPM]	1.6	2.5
GPF - Gallons Per Flush	GPM - Gallons Per Minute

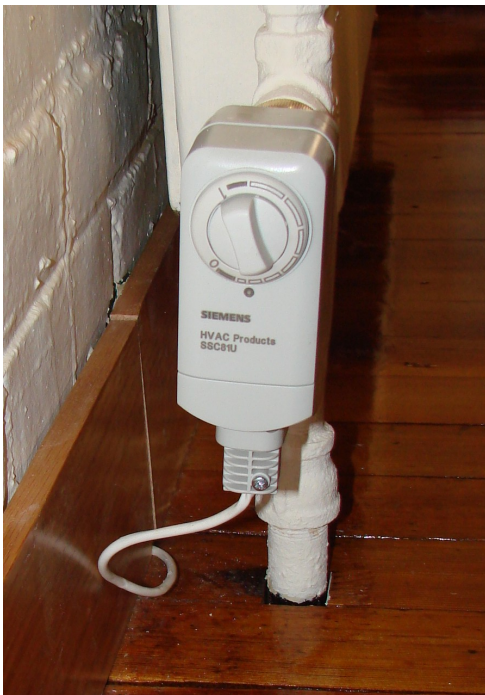
**HVAC Actuator**

The HVAC design for the renovation area is a two pipe system with cooling only fan coil units, interlocked with individually controlled steam radiators for heating. Outside air ventilation is mechanically provided by a local air handling unit. The ventilation system exceeds the minimum outside air CFM's by 30%, to improve the IAQ.
